Re: May 2013 Monthly Progress Report
Administrative Settlement Agreement and Order on Consent for Removal Action
U.S. EPA Region 10 Docket No. CERCLA 10-2009-0255
Gasco Sediments Site within the Portland Harbor Superfund Site

Visual Observations Log Form

Project Name: NW Natural – Gasco

Monitoring Period: Monthly (Year 7)—May 2013

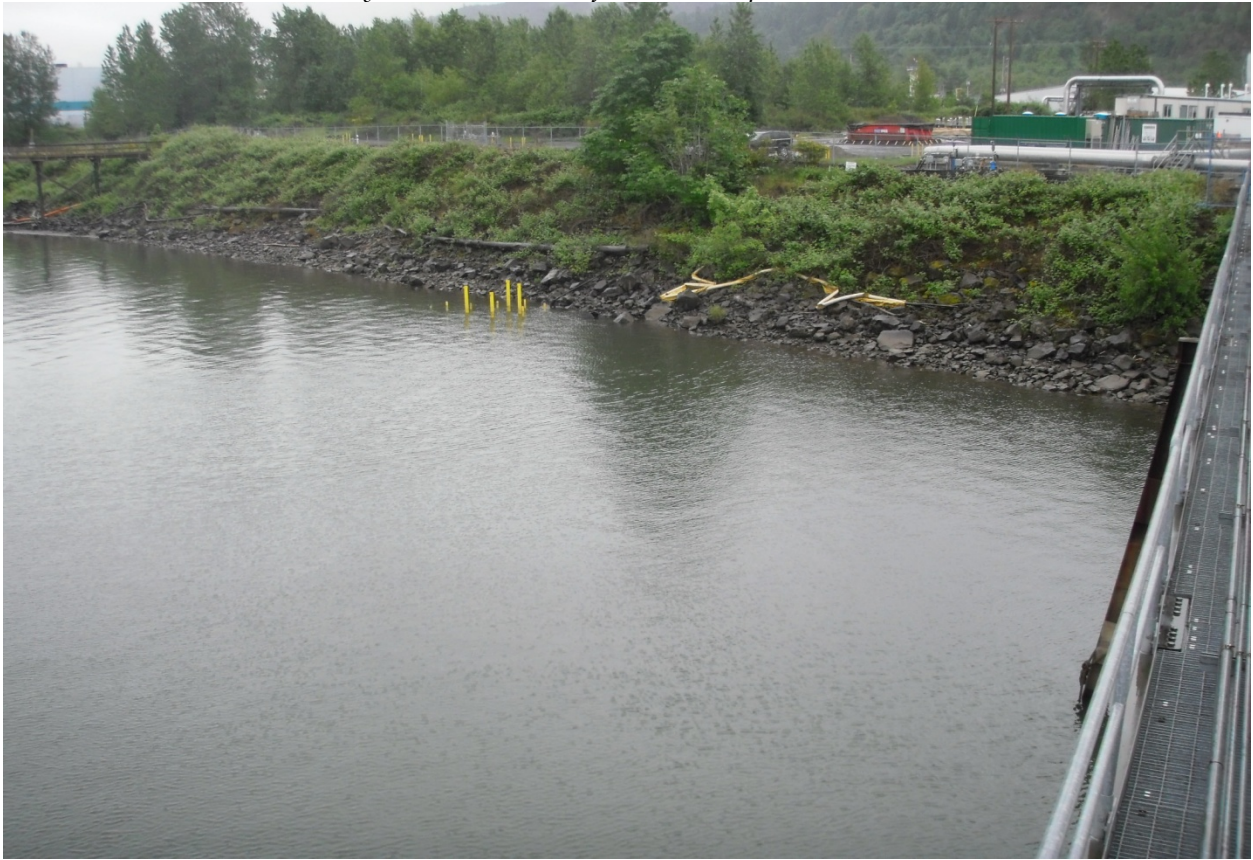
Observations of Erosion/Deposition: No erosion/deposition is evident along the shoreline. The shoreward extent of the cap was not visible due to high river elevation and the organoclay mat material was submerged. (Photo 1).

Photo 1 — *River level currently above the extent of sediment cap (5/22/13):*

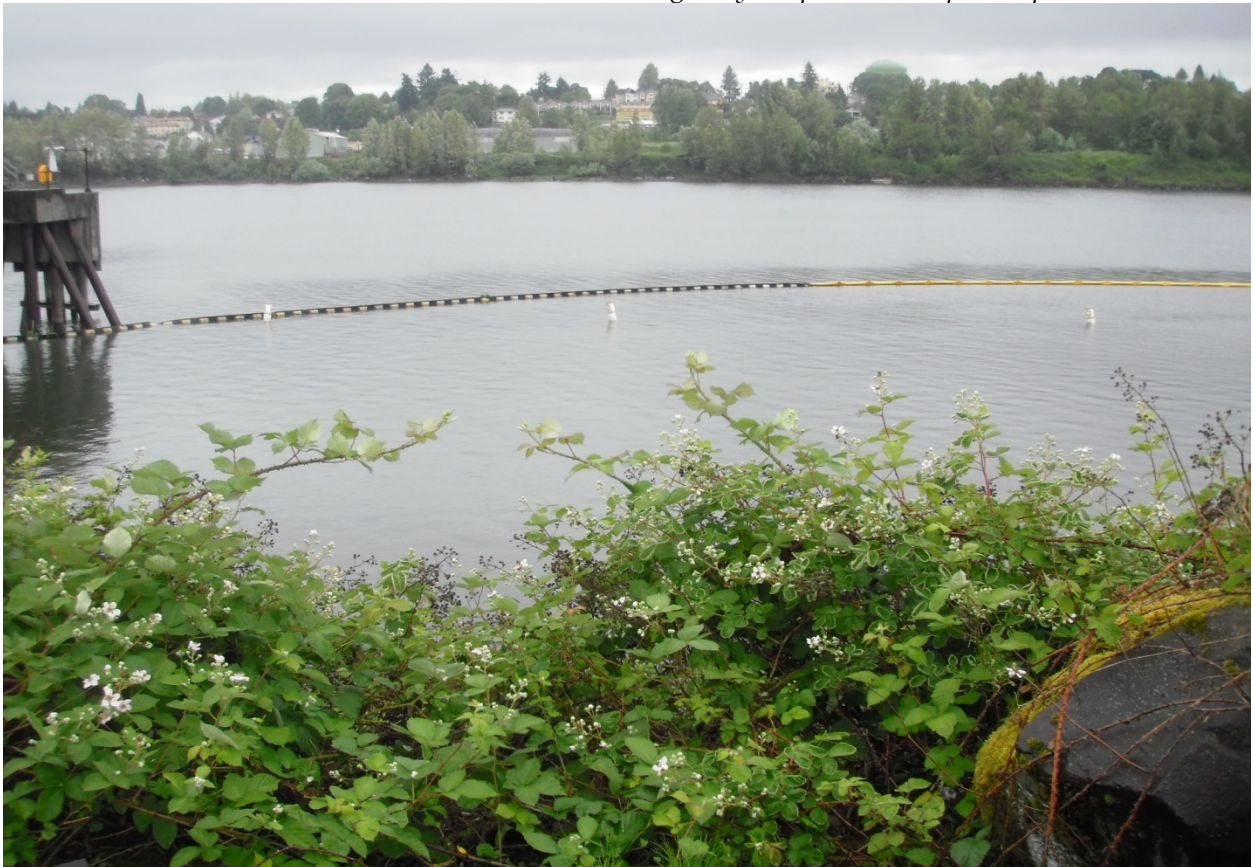
Observations of Long-term Controls (i.e., oil booms, organo-clay mat, etc.) During the observation, the Fuel and Marine Marketing (FAMM) containment boom was placed across the cap area, between the upriver corner of the ship dock and the wooden dolphin (near the upriver extent of the site and near the Siltronic Corporation outfall). Buoys that identify the cap area to mariners are in place as installed. The position of the FAMM oil boom, warning buoys, and a general overview of the site shoreline is shown in Photo 2.

Photo 2 — *FAMM oil boom shown and mariner warning buoys in place across pilot cap area. 5/22/13):*

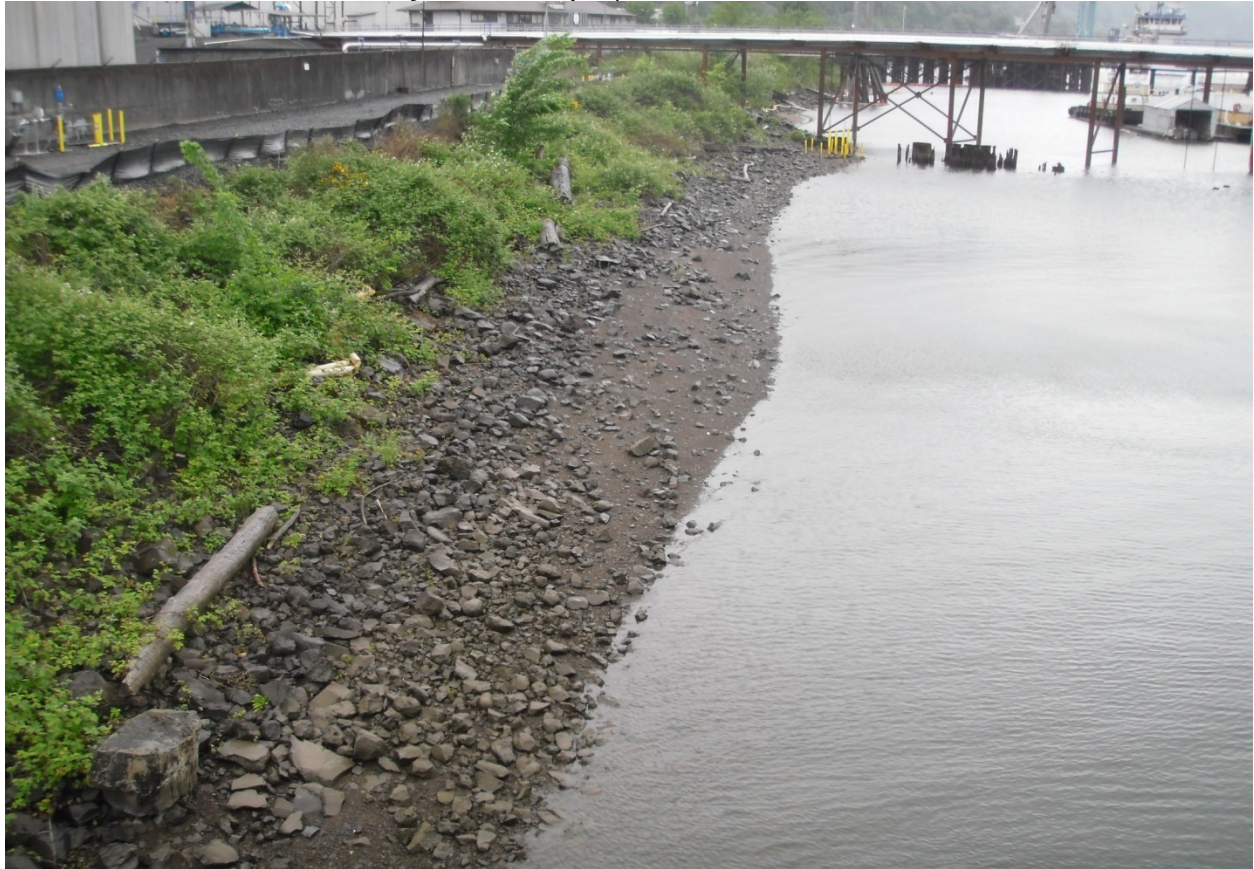
Other Comments: No sheen is evident in or around the cap area. Photo 3 shows the water surface and shoreline immediately downriver of the sediment cap.

Photo 3 — *Conditions immediately downriver of cap area (5/22/13):*
